# Improving turn safety at 53<sup>rd</sup> & Lake Otis

Donald N. Anderson

15 September 2009

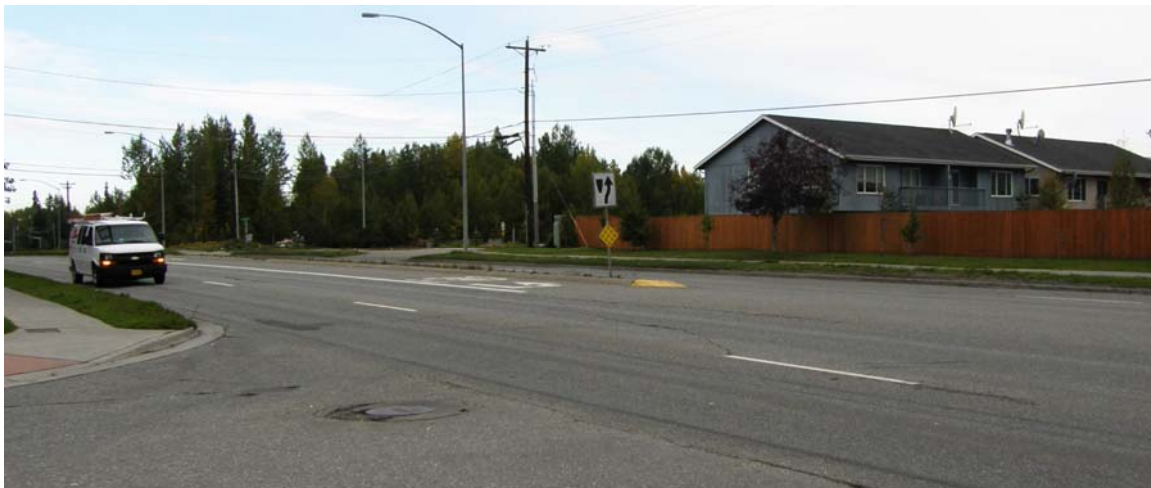
**Lake Otis and 53<sup>rd</sup> intersection from the southwest. Turns from 53<sup>rd</sup> (foreground) to northbound on Lake Otis cross 2 southbound lanes and a turn pocket (not used for turning) to reach the fast northbound lane beyond the directional sign.**

The most difficult and dangerous turn is from 53<sup>rd</sup> northbound on Lake Otis. The lane dividers for a left turn lane from Lake Otis onto the non-existent eastern extension of 53<sup>rd</sup> make cars entering from 53<sup>rd</sup> proceed directly over into the left traffic lane. They thus need three (or better 4) lanes clear of traffic before making the turn and must be particularly aware of traffic coming up over the rise from the Waldron light.

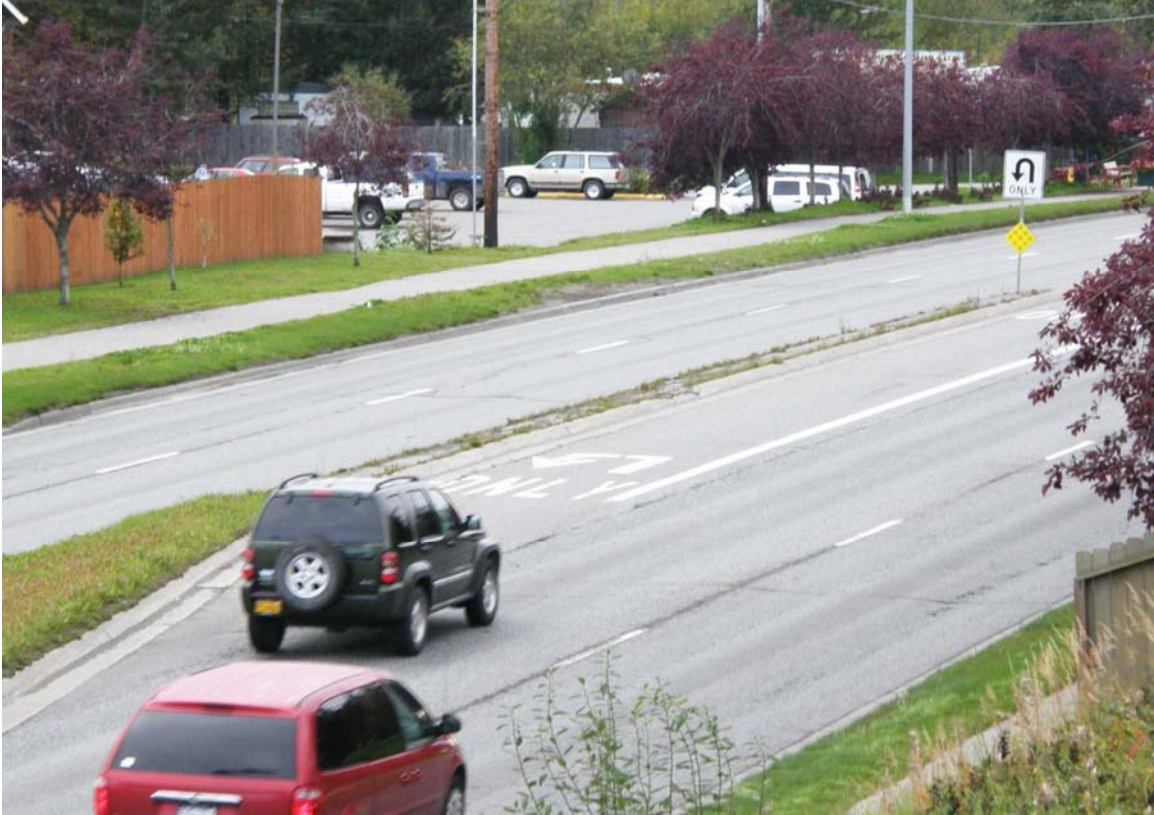
**In this picture from the northwest it can be seen that the turn pocket is used as a U-turn lane only.**

Since no eastern extension of 53<sup>rd</sup> will ever be built (a subdivision occupies the land) the turn lane is rarely used and then only for a U-turn on Lake Otis.

- 1) Remove the lane divider from 53<sup>rd</sup> back to where the useless left turn pocket starts (photo above). This would make it possible for multiple cars turning north from 53<sup>rd</sup> to enter the central lane and select the safest time to continue into the regular fast lane northbound,
- 2) Remove the lane dividers from 53<sup>rd</sup> all the way back to the pocket for the Waldron turn lane (photo on left). The Waldron turn lane is about 2 blocks north and the same lane divider as seen at 53rd continues to Waldron. This would permit the safer turn and permit a bit more space to match speeds with fast lane traffic, and
- 3) Remove the dividers as mentioned in (2) and add a single narrow divider between the center lane and the southbound lane of Lake Otis. In addition to the safety features mentioned above this would continue to deny left

Of these the first change is so minor that it probably could be done by a regular maintenance crew. The others will require more work.

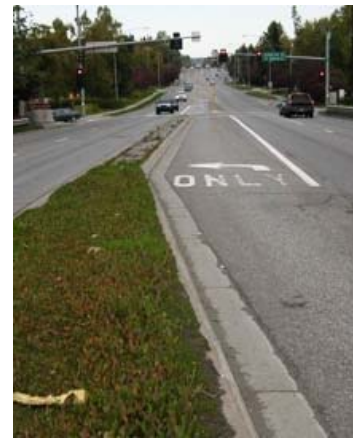
**Turn pocket for Waldron.**

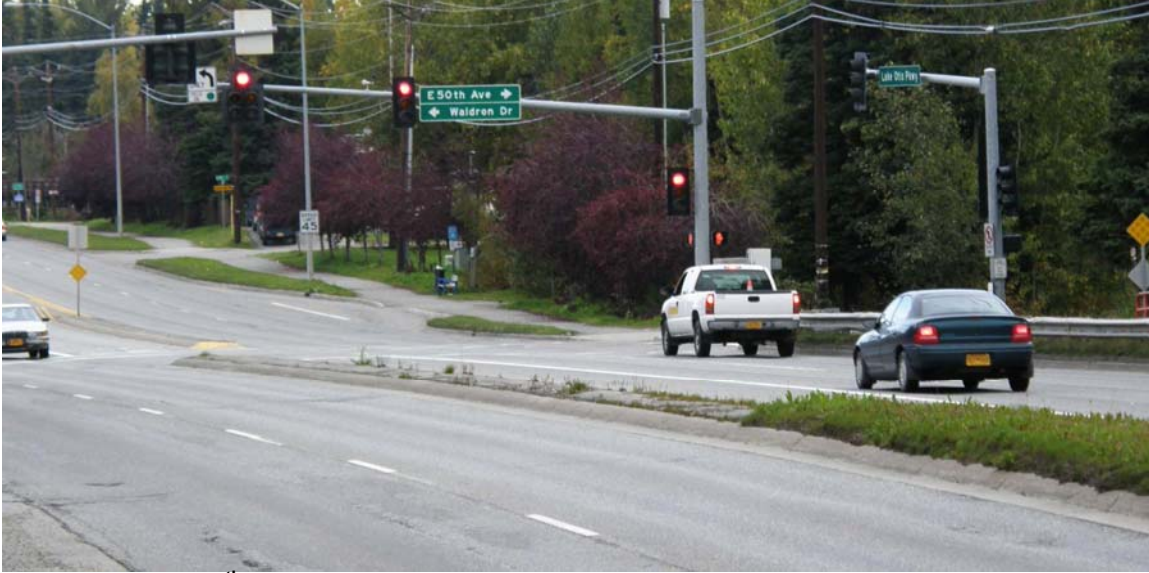
**Waldron and E.50<sup>th</sup> intersections from the SW. The left turn pocket with the light forms a continuous divider with the dividers at 53<sup>rd</sup>.**

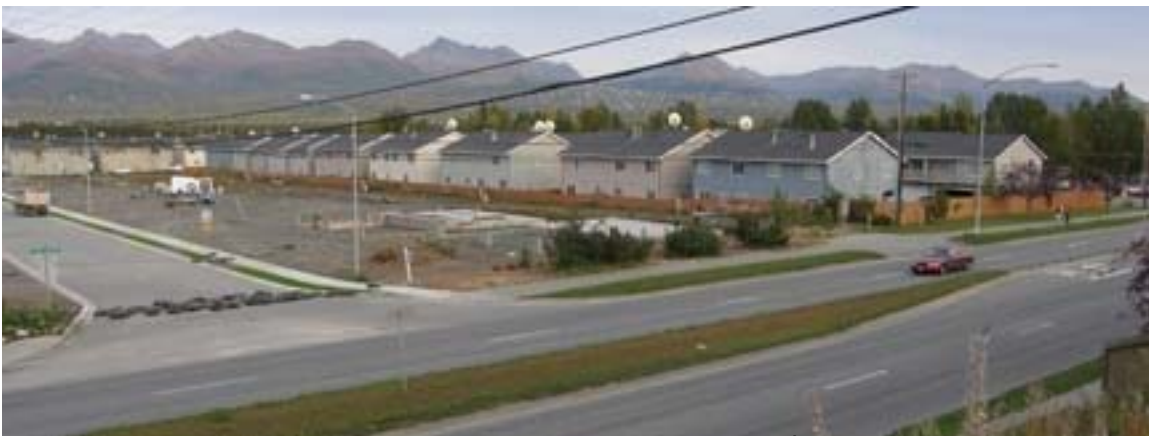
**New subdivision street entering from east just north of the 53<sup>rd</sup> turn pocket. The next curb cut to the south is not used.**

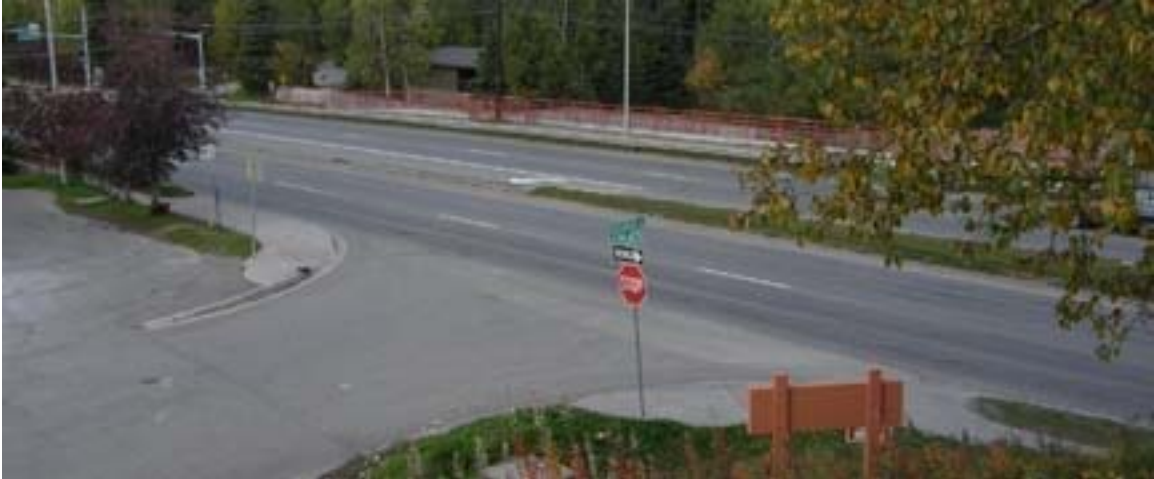
Entering from the west is Greenridge which is the access to the two apartments buildings on its north. Greenridge is connected to Waldron west of the two apartment buildings giving residents access to a light for north bound Lake Otis traffic.

**Greenridge enters from the west one block south of Waldron.**
